Salt Spray Fog Test

Fittings

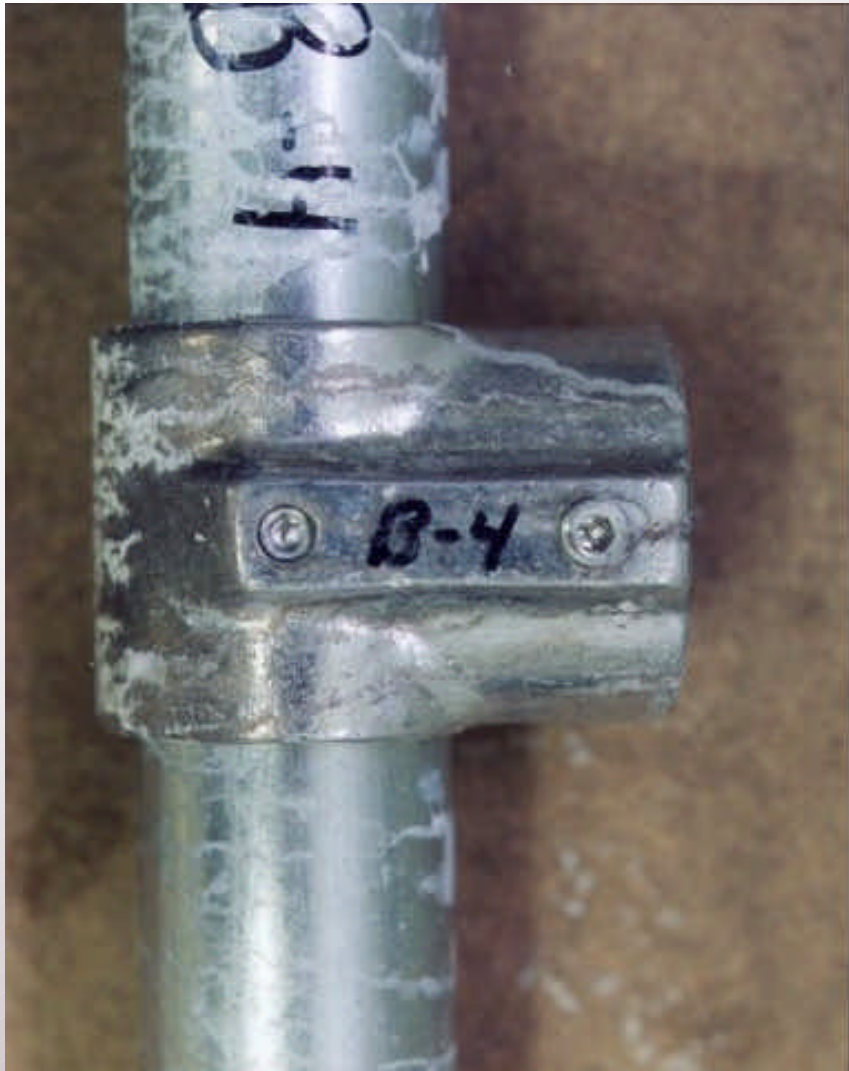
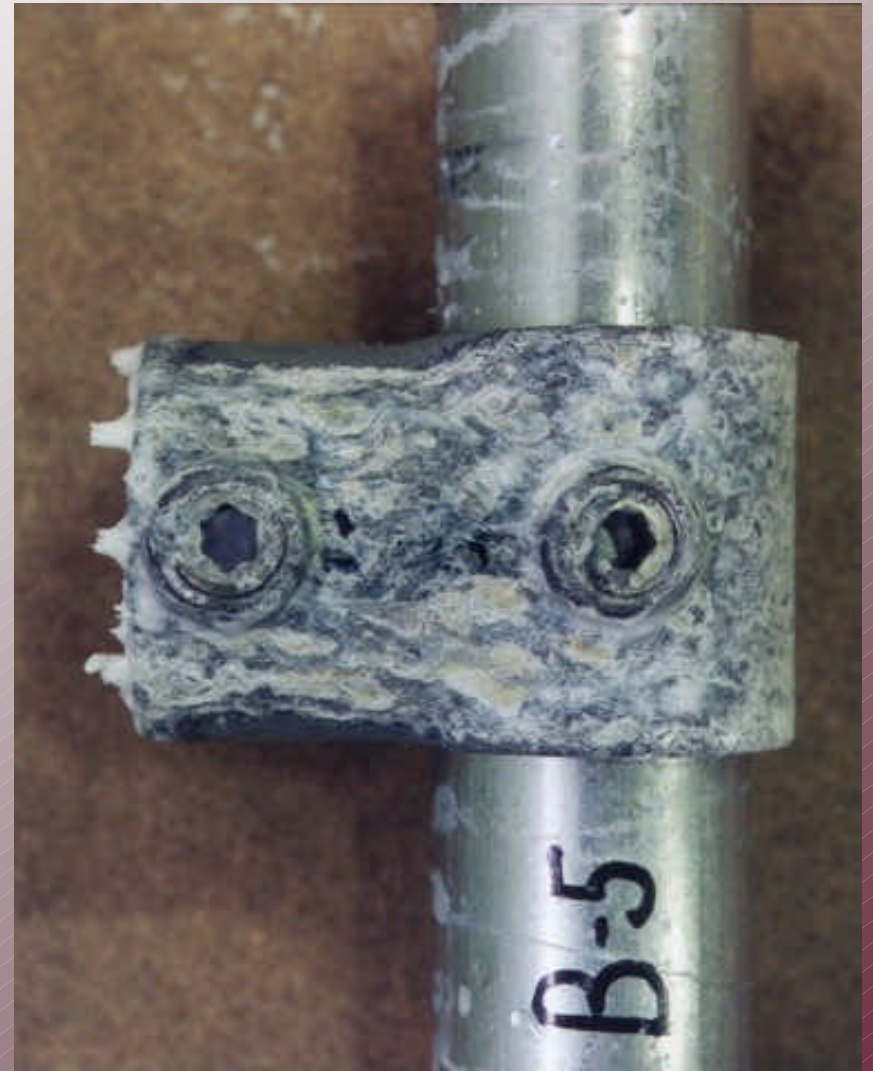
Fittings At 48Hrs

- The Hollaender fitting accrued no structural damage due to “galvanic reaction”
- Malleable iron fitting started to show red rust after 48 hrs
- After 1000 hrs the malleable iron fitting was unable to be loosened or moved
- After the same time the Hollaender fitting was able to be loosened, moved, and tightened back to the proper torque
- Copyright 2001 The Hollaender Manufacturing Company
